**A Half Century of Lake and Watershed Management  
in  
Maine's Only Watershed District.**

**cobbossee**  
watershed district

Bill Monagle, Executive Director

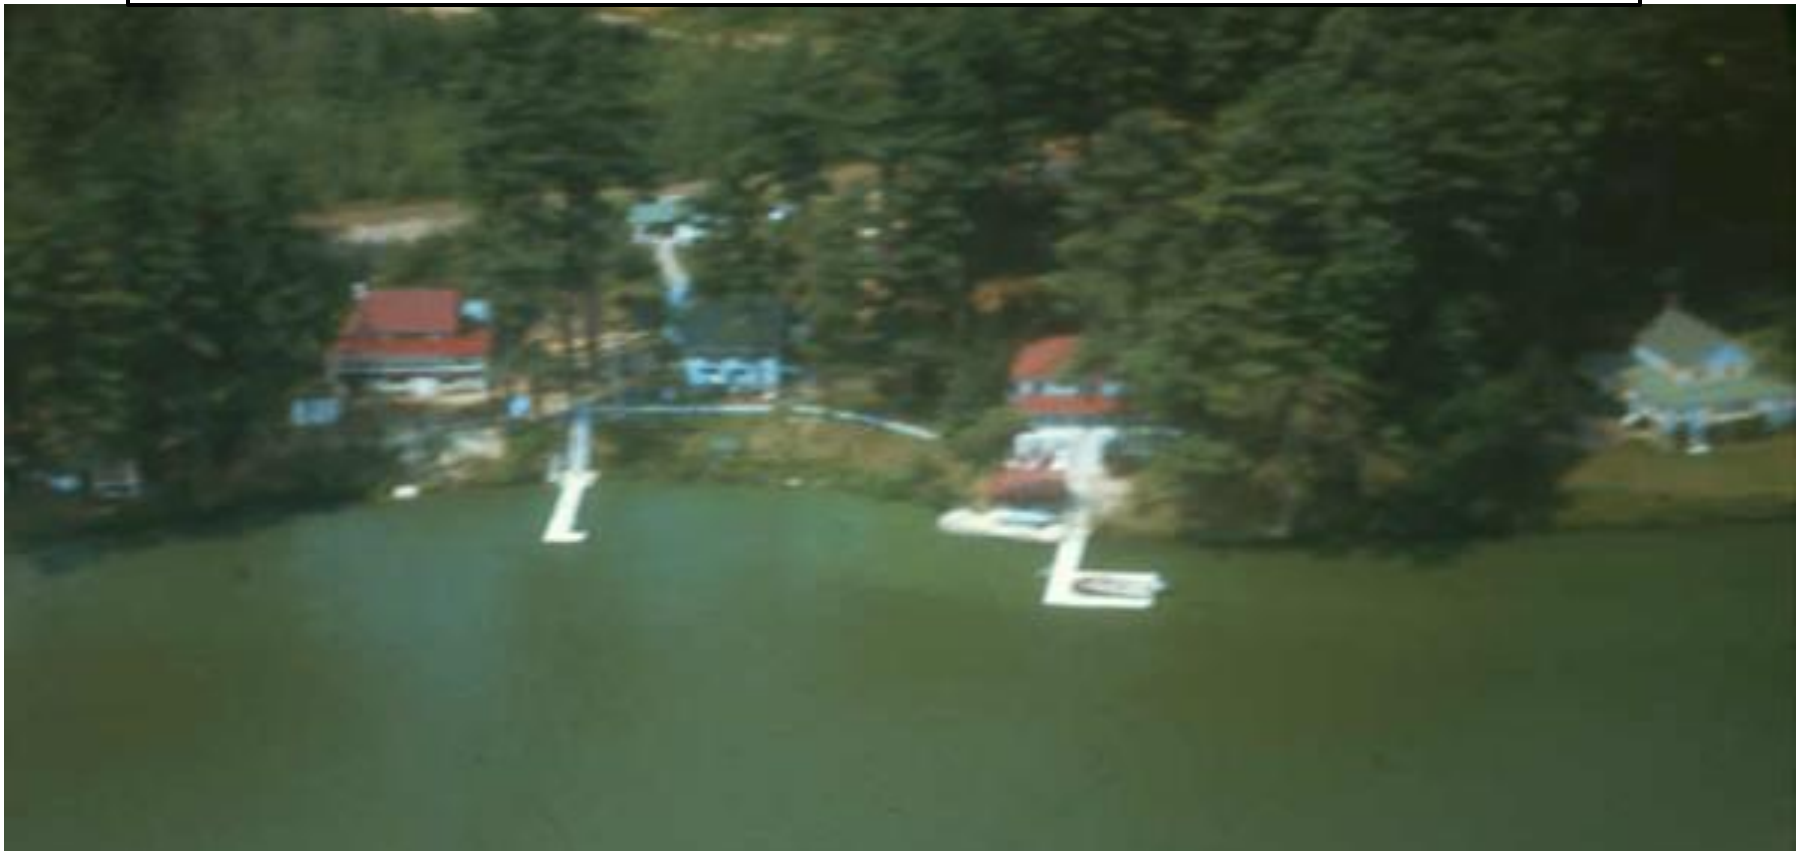
Crisis/Impetus #1: Annabessacook Lake algae bloom, early 1970's

DATE FOR DATA: AUG 13, '71 9:30 AM

PLACE	SECCHI DISC	TEMP
#1 NULL STR	1'-9"	73°
2 DAM BODY-UPPER	1'-9"	74°
3 " " (HUNTER'S)	1'-6"	74°
4 FRENCHMAN'S COVE	1'-6"	73°
5 HUNTERS OUTLET	1'-3"	75°
6 BIG ISLAND (WEST)	0'-9"	76° (HUNTER'S)
7 " " (WEST)	1'-3"	74° " "
8 DAM BODY - LOWER	1'-6"	74°
9 S.W. COVE (HUNTER STR)	2'-0"	75°
10 OUTLET	1'-3"	76°

(green algae on surface all over)  
 phospor containing imp. with  
 St. Jacobs  
 August 13, 1971  
 Secchi Disk transparency: 9 inches to 2 feet

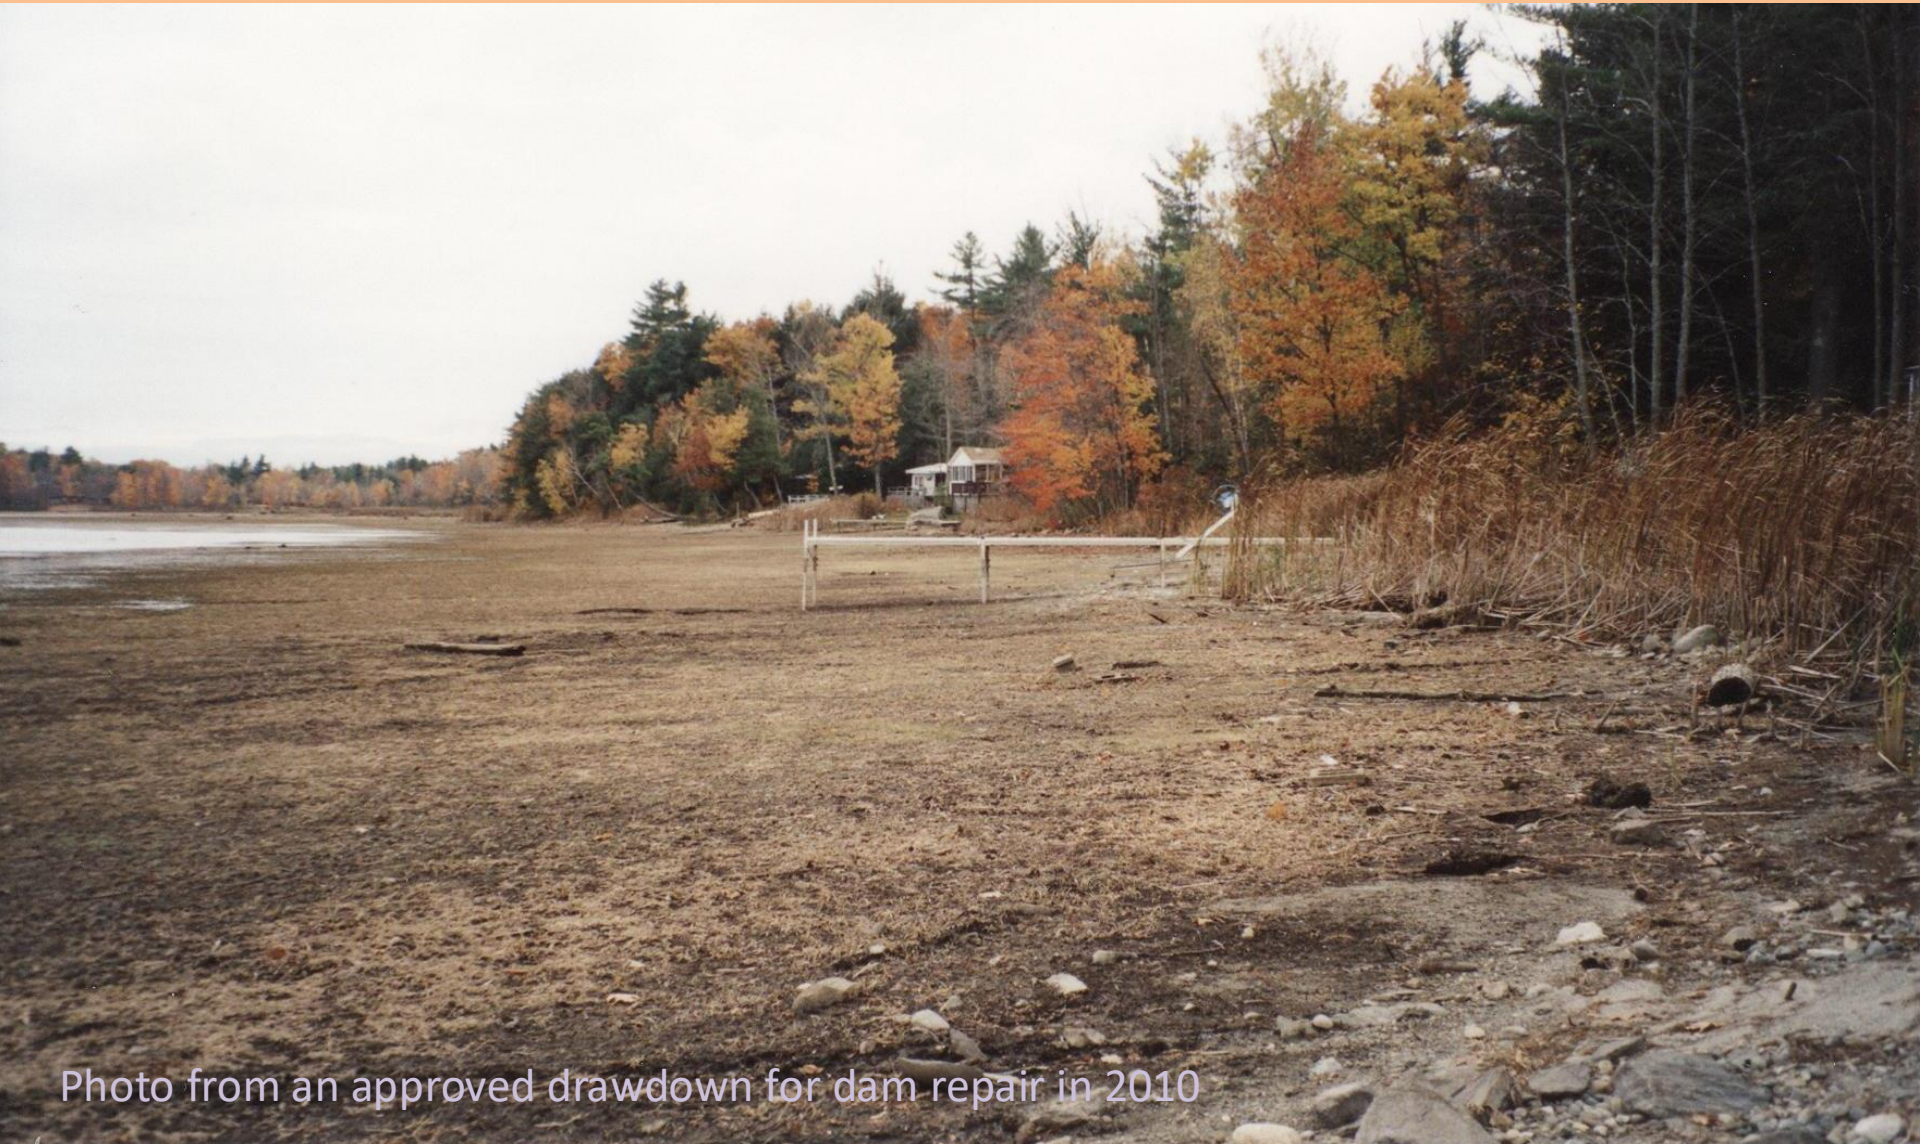
Photo from an approved drawdown for dam repair in 2010

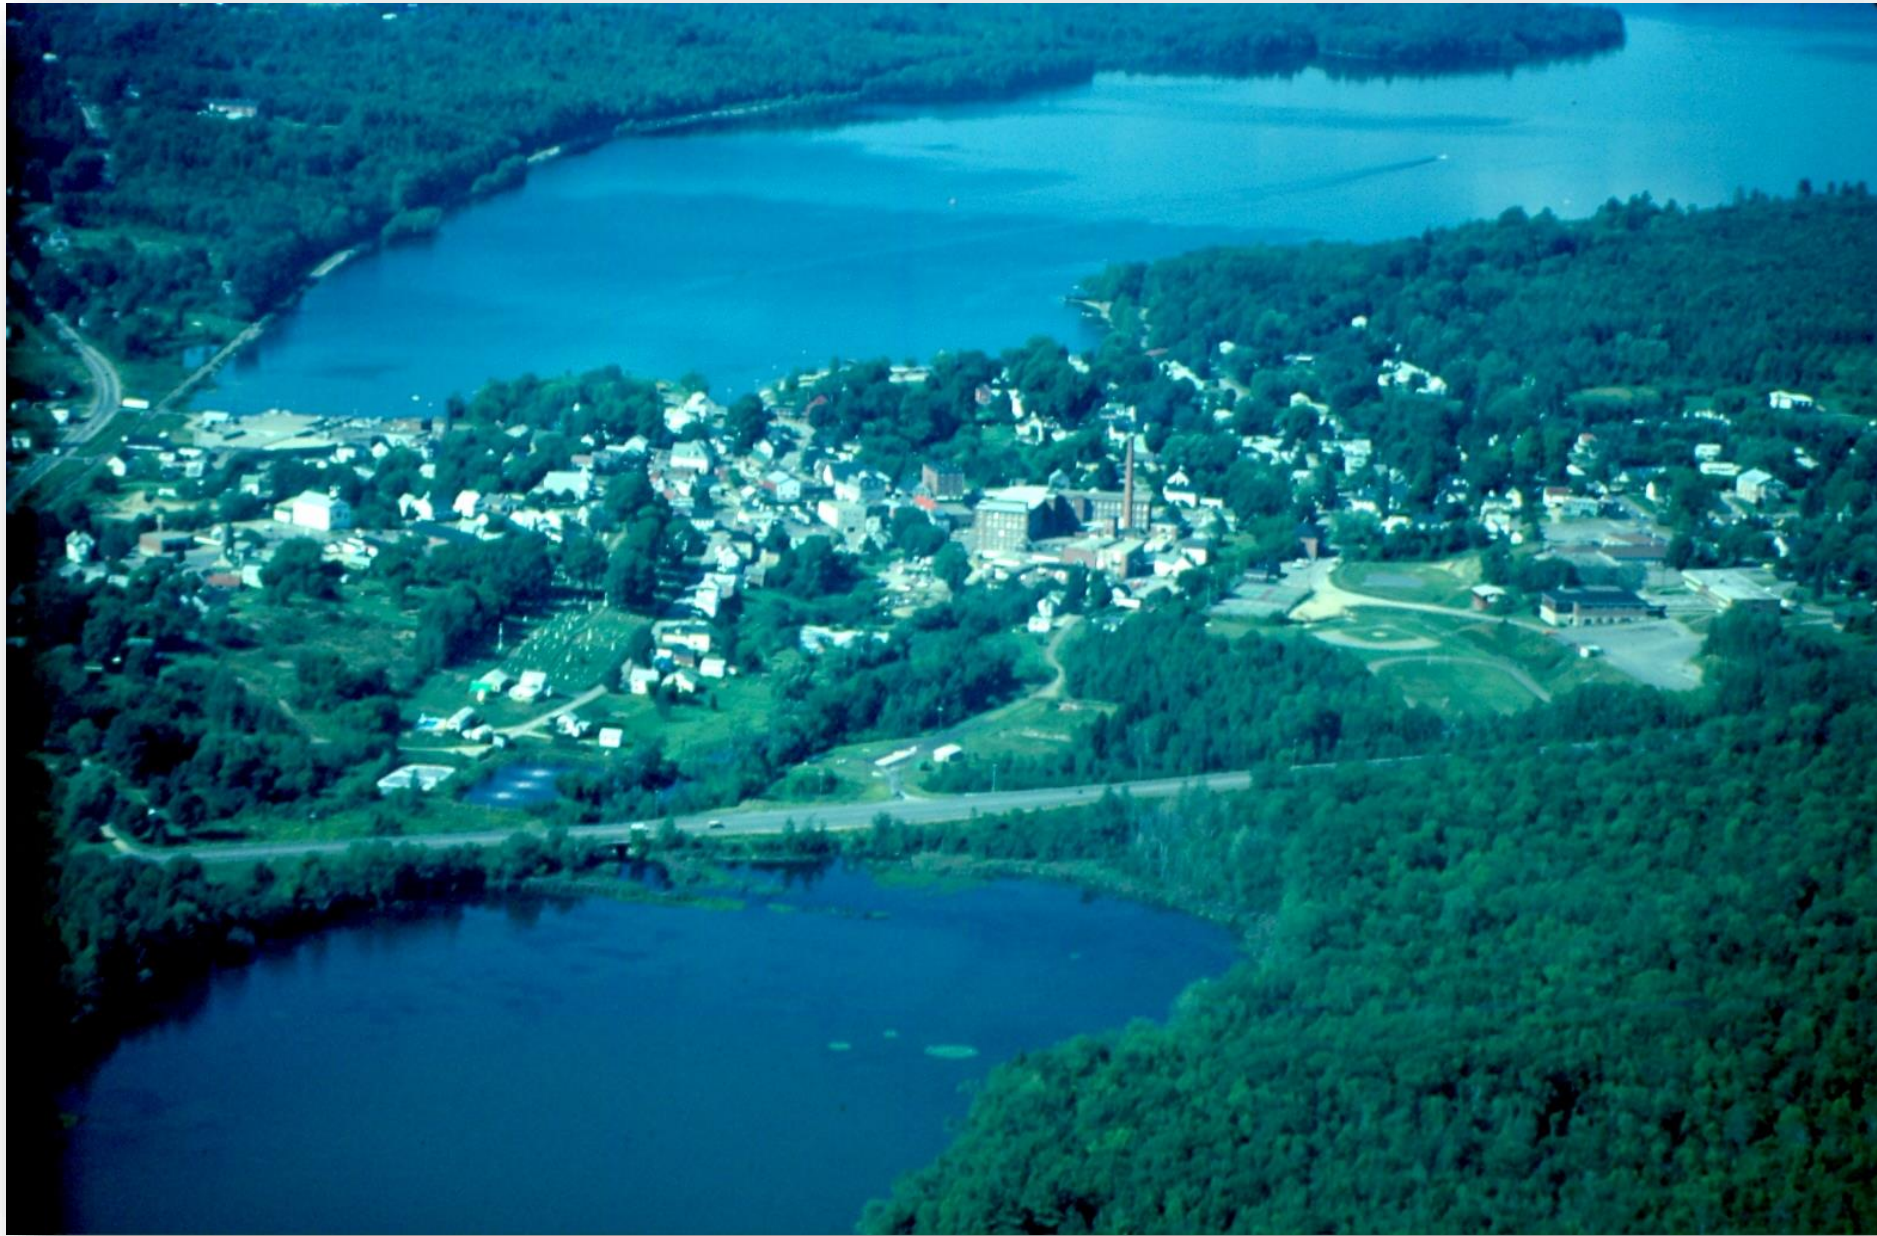
Maranacook Lake, top – downtown Winthrop with Carleton Woolen Mill, center – Annabessacook Lake, bottom

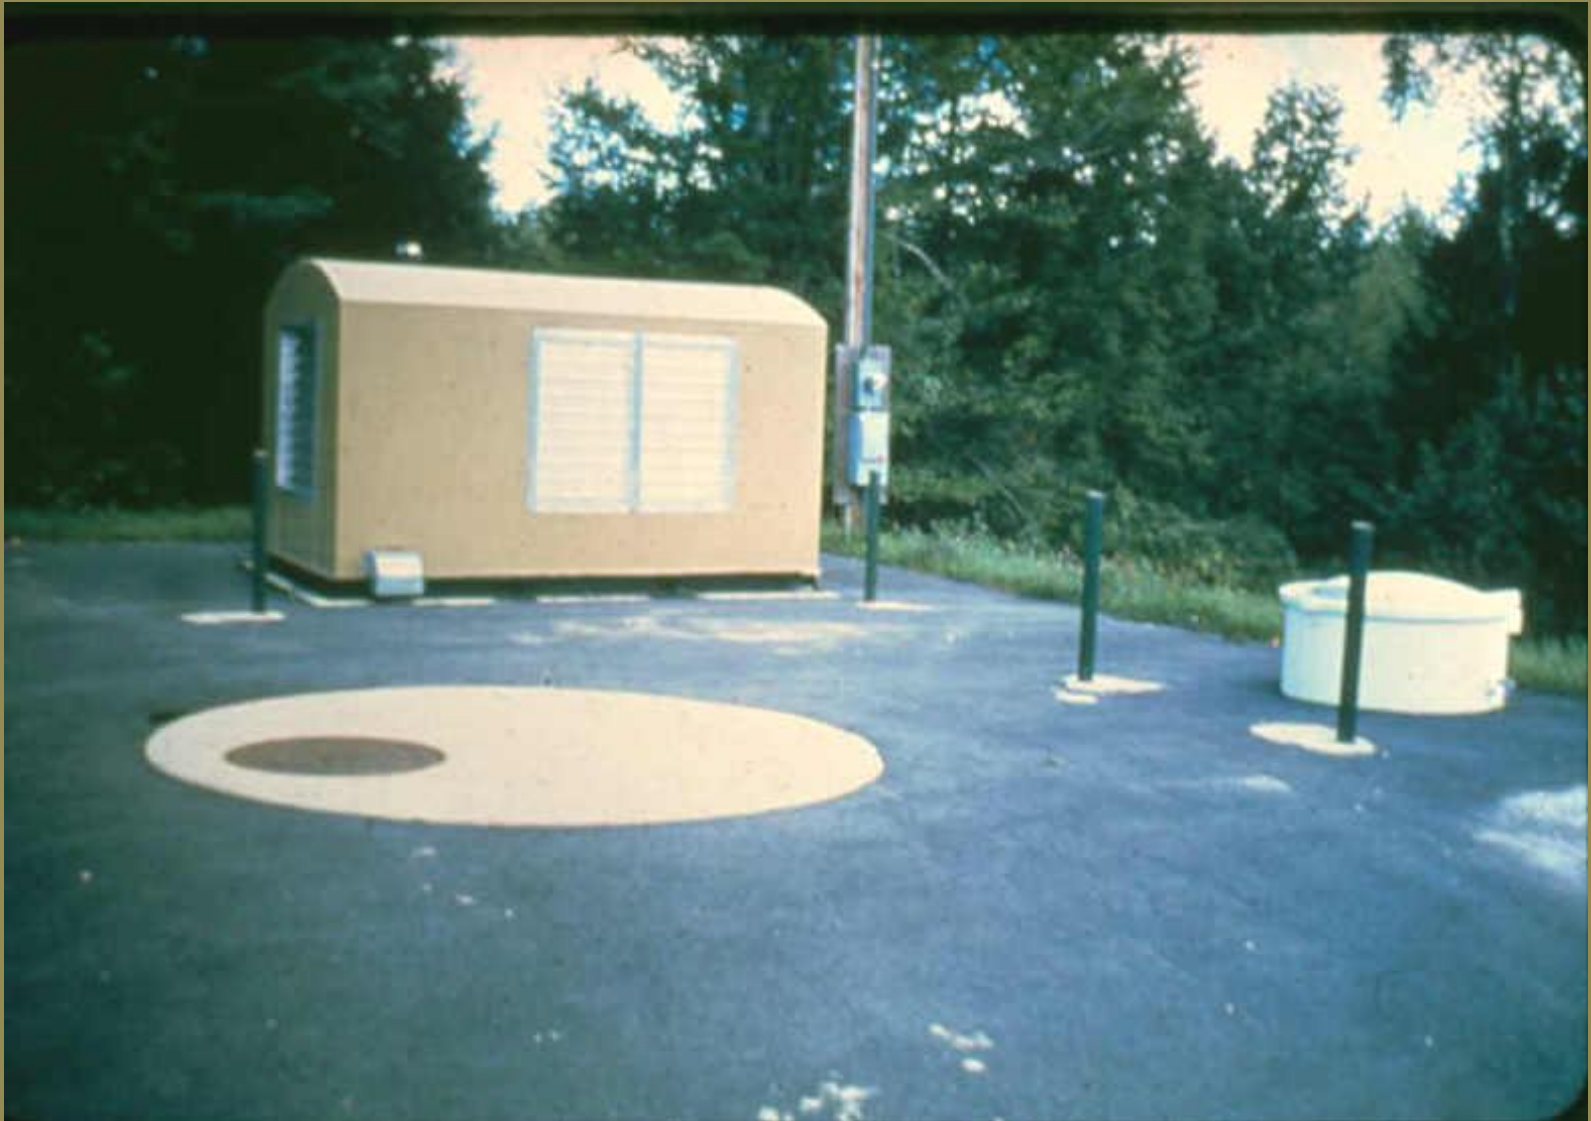
## Wastewater/sewage pump station

Winthrop sewage diverted to Augusta treatment plant in 1973; North Monmouth in 1976

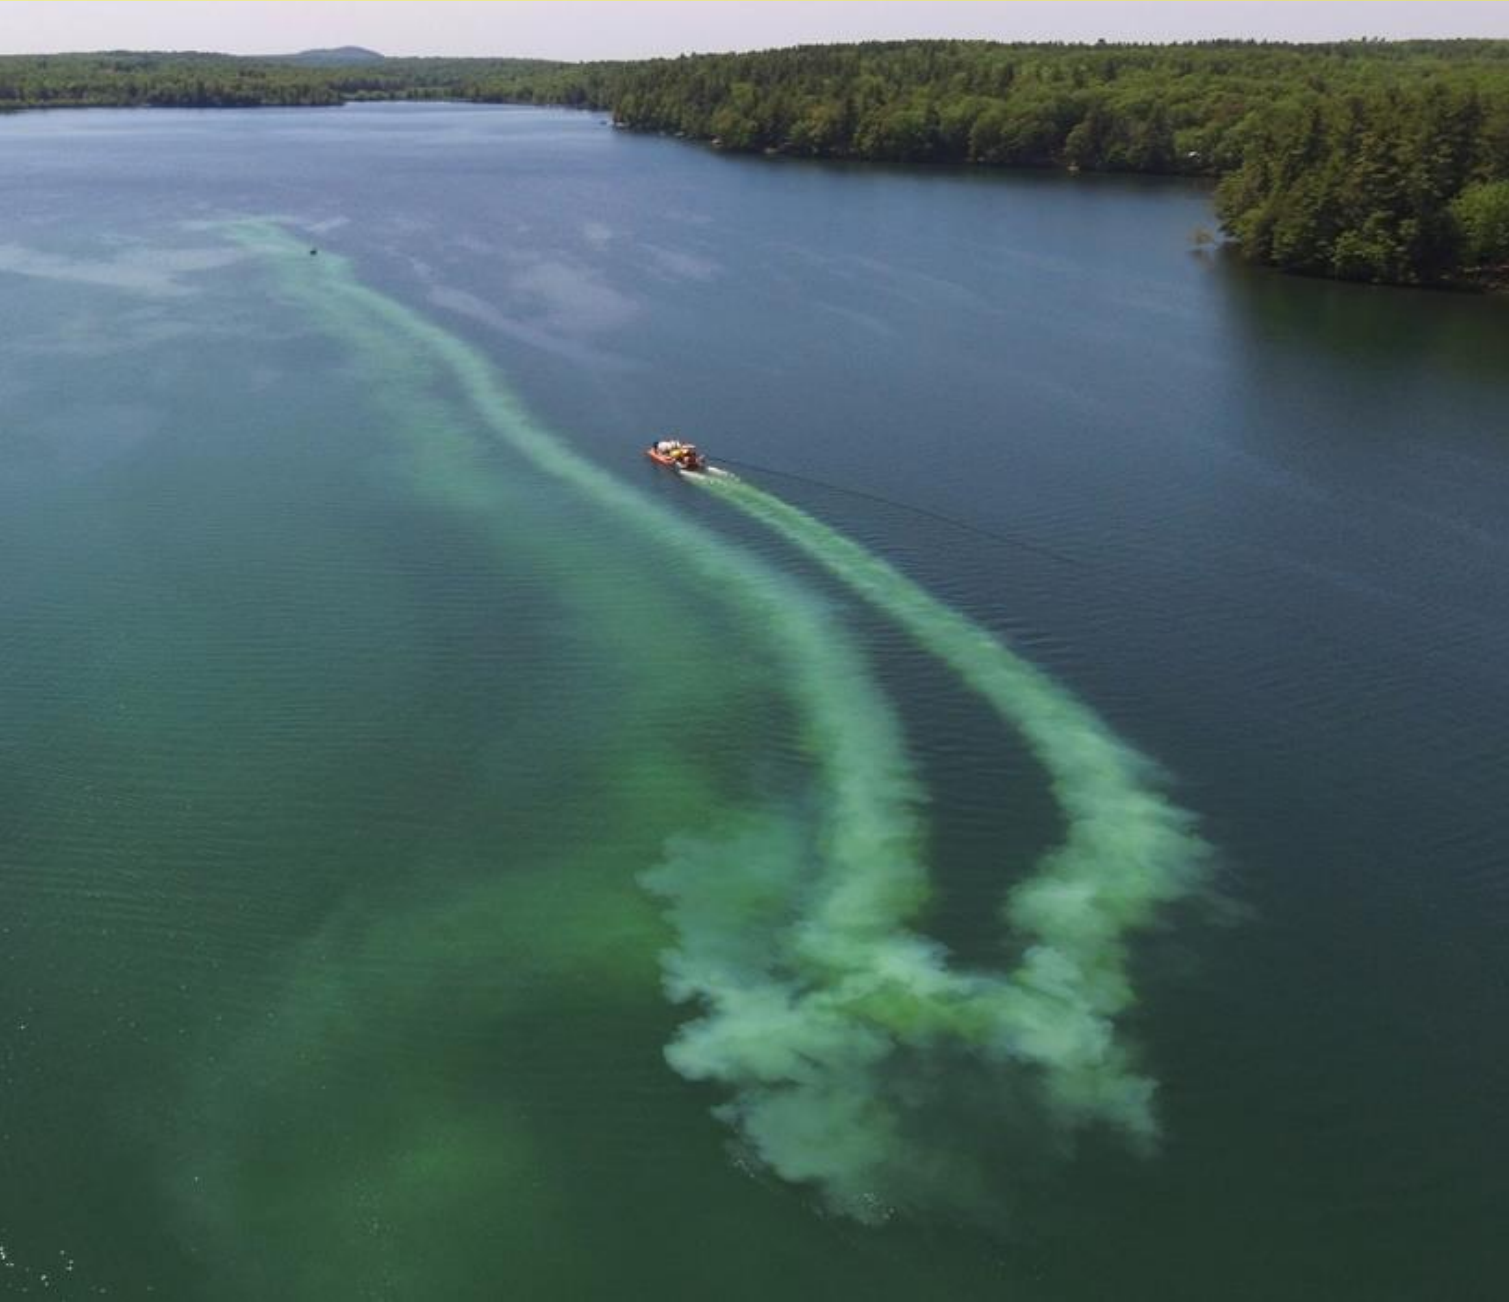
# Environmental Results: Cochnewagon Lake WQ Restored!

**Phosphorus goals were achieved.**

**No blue-green algae blooms since treatment.**

The alum floc settled to the bottom and within an hour the plume was not visible.

This treatment was a great success, but alum treatment longevity is finite.

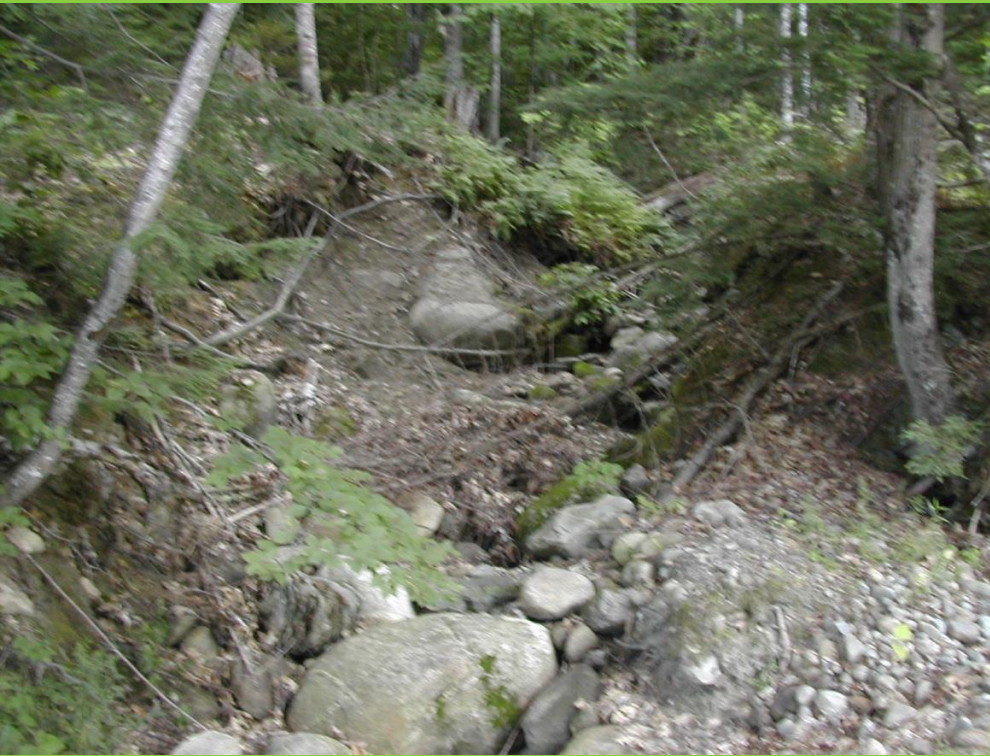
## Merganser Lane

Before

The condition of an expansive gully between Merganser Lane and the private driveway that was created by excessive outfall from an 18" HDPE culvert (not visible).

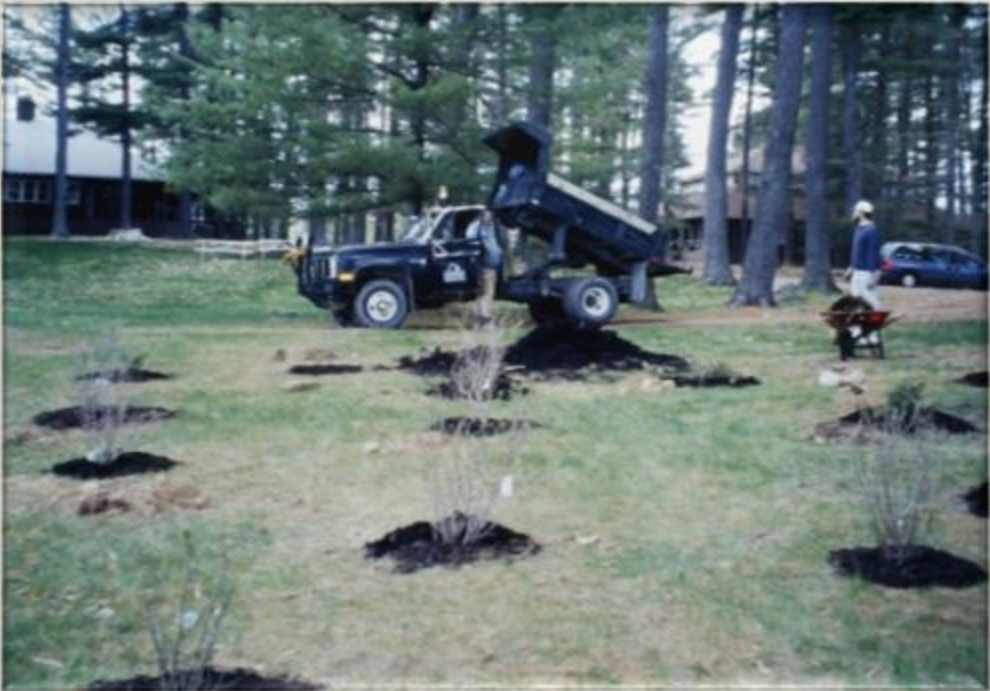
Creating a buffer at YMCA Camp  
Cobossee Lake – 1997  
CWD and Cobossee citizens

A buffer strip of densely planted, diverse, vegetation is one of the best ways to protect lake water quality.

**Twenty+ years after Cobbossee Watershed District planted this vegetated buffer at the YMCA Camp on Cobbossee Lake, it is a great example of a functional buffer strip.**

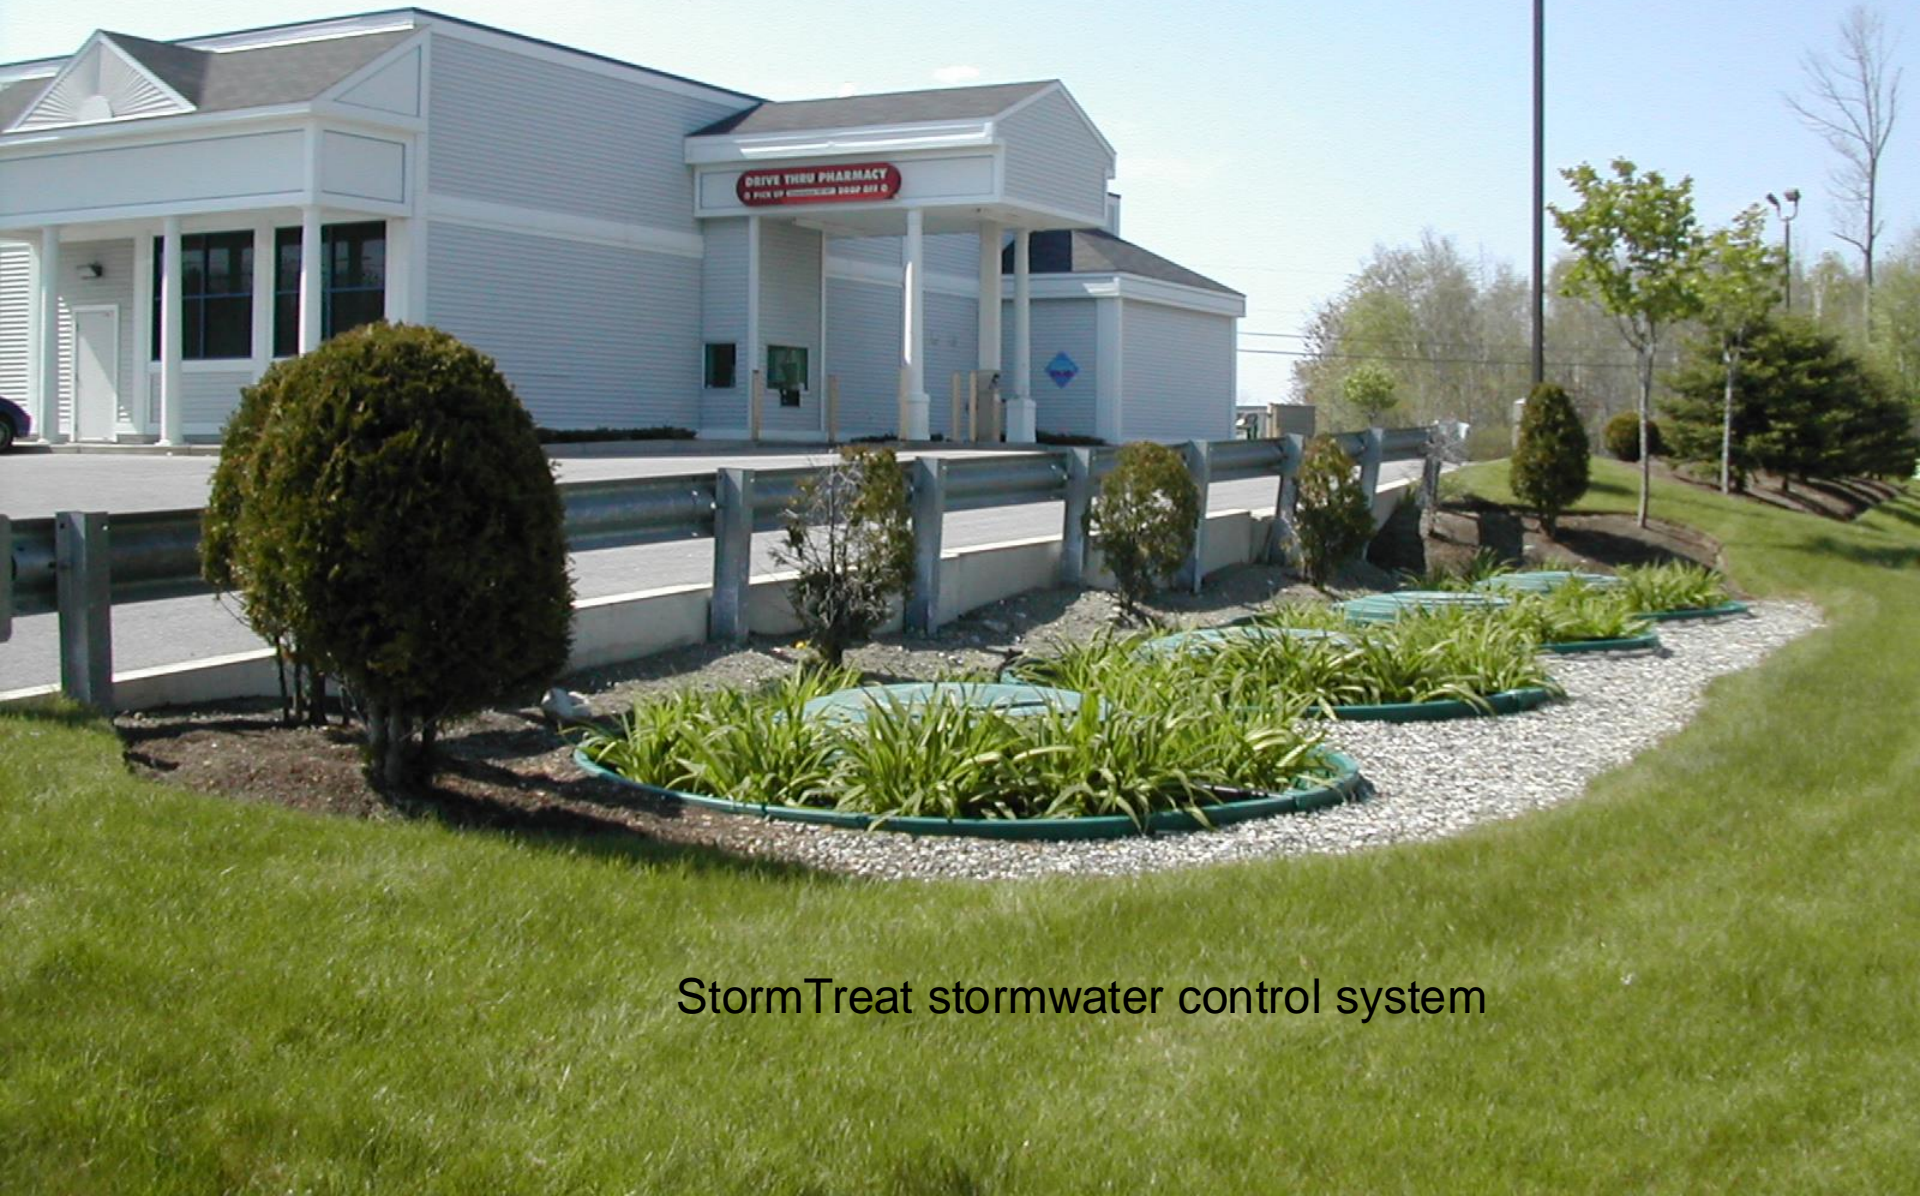
StormTreat stormwater control system

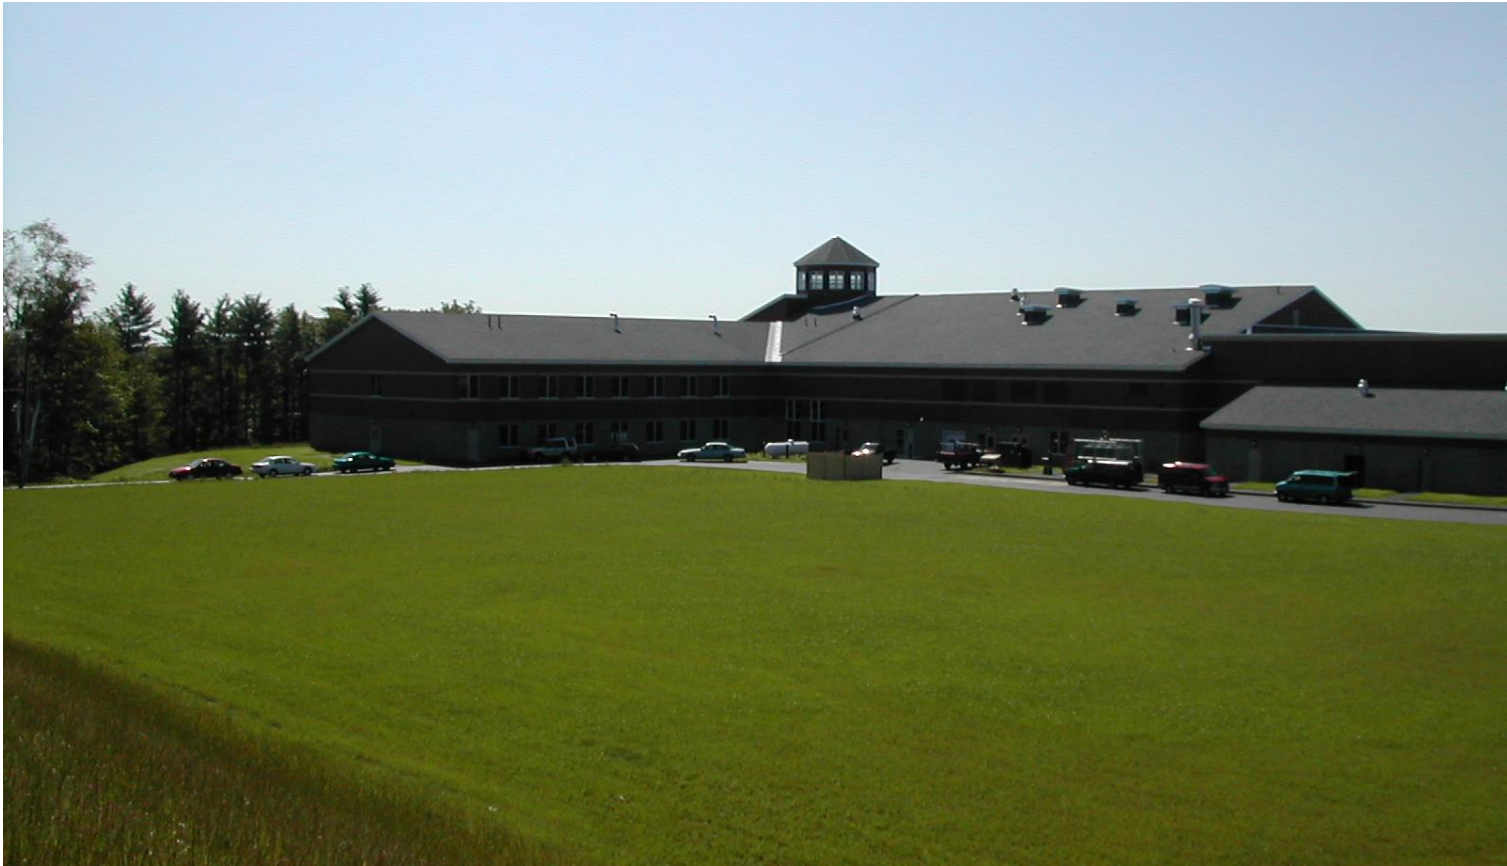
The scale of development required payment of a “compensation” fee to be used to remove phosphorus elsewhere in the watershed.

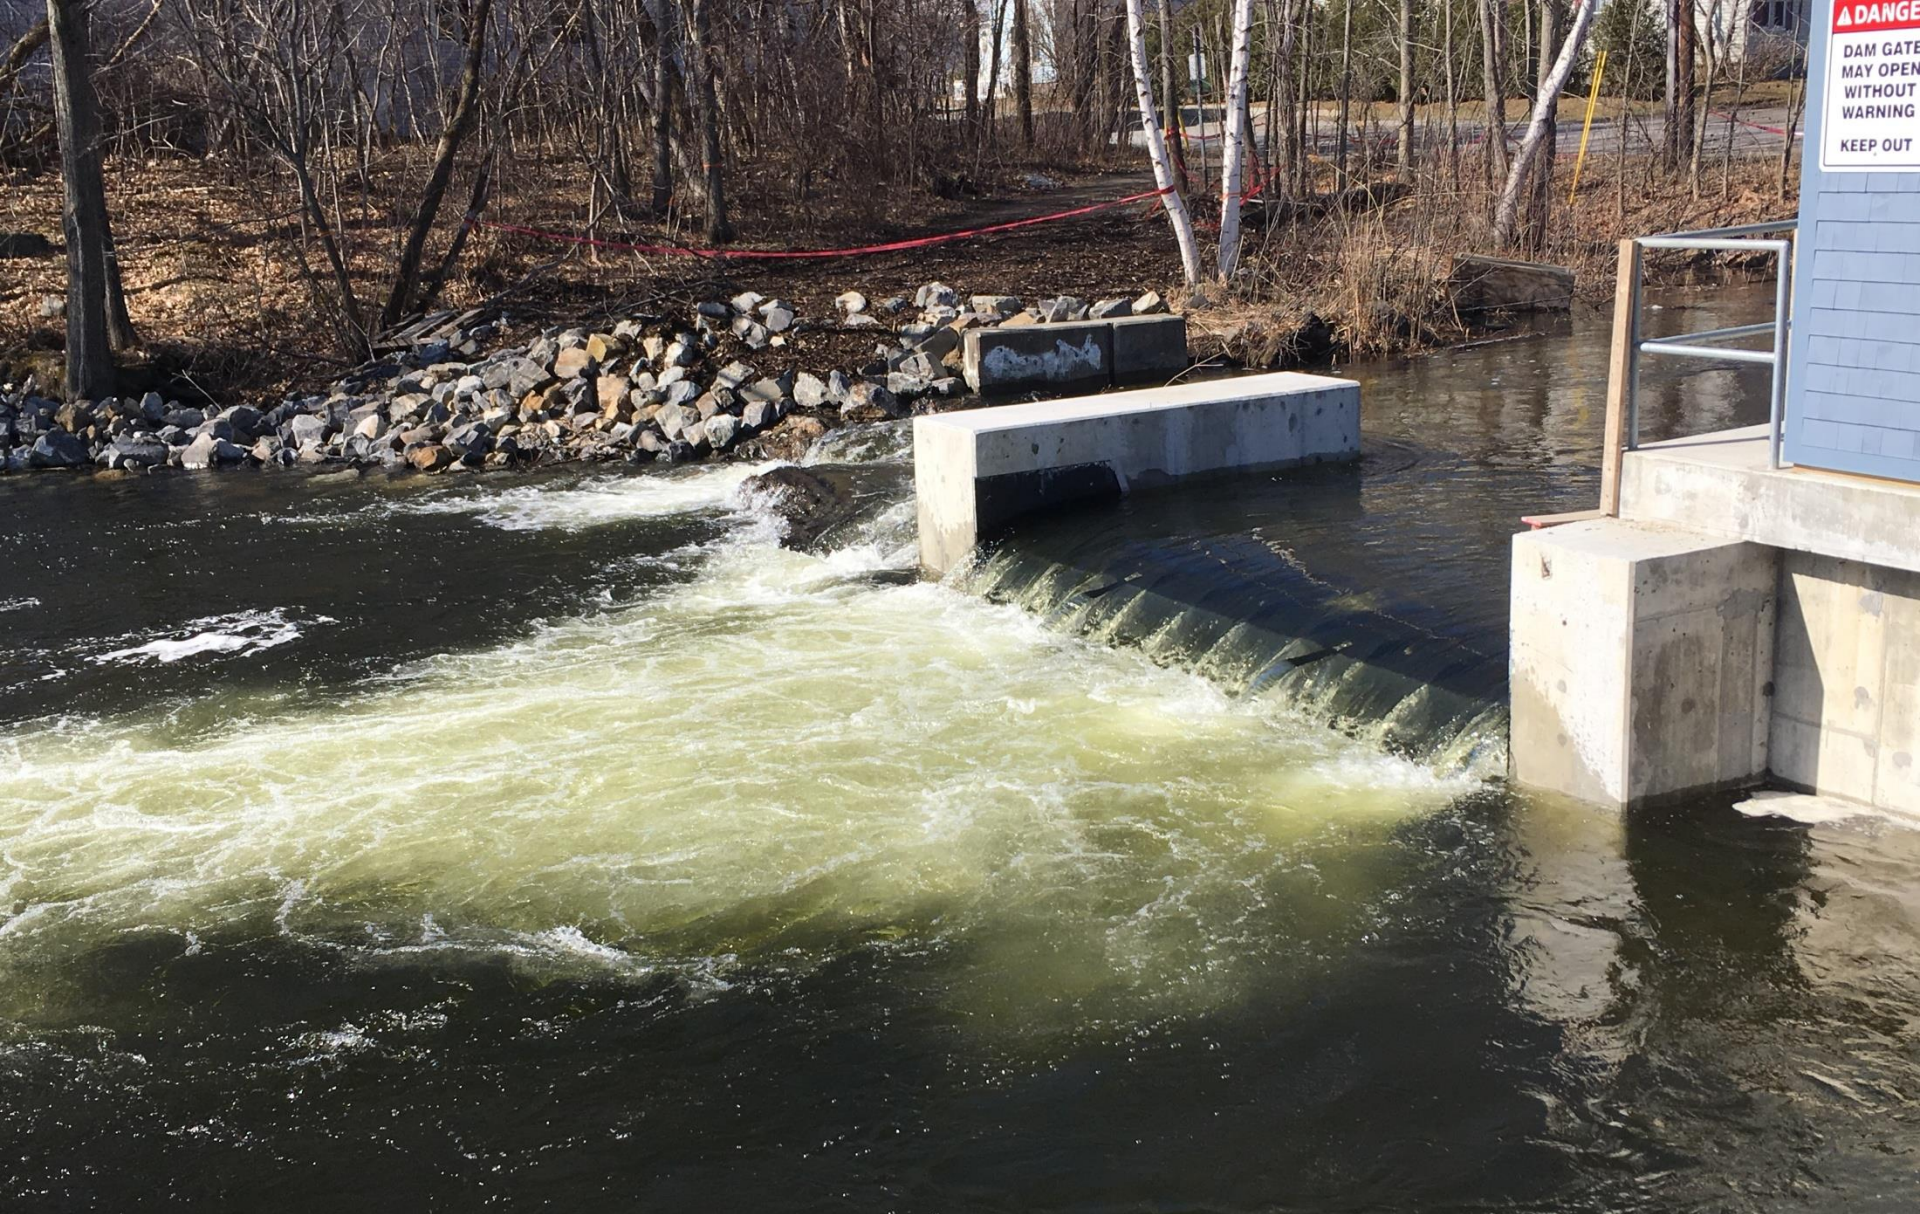
Reconstructed Maranacook Lake Dam:  
improved water discharge and lake level control
